**Inspection Report**  
**Minerals Regulatory Program**  
Report Date November 2, 2005

**Mine Name:** Big Thomson Clay Mine  
**Operator Name:** Brown Brothers Construction Company  
**Inspector(s):** Paul Baker  
**Other Participants:** None  
**Mine Status:** Inactive (at present)

**Permit number:** S/017/047  
**Inspection Date:** September 12, 2005  
**Time:** 6:30-7:00 PM

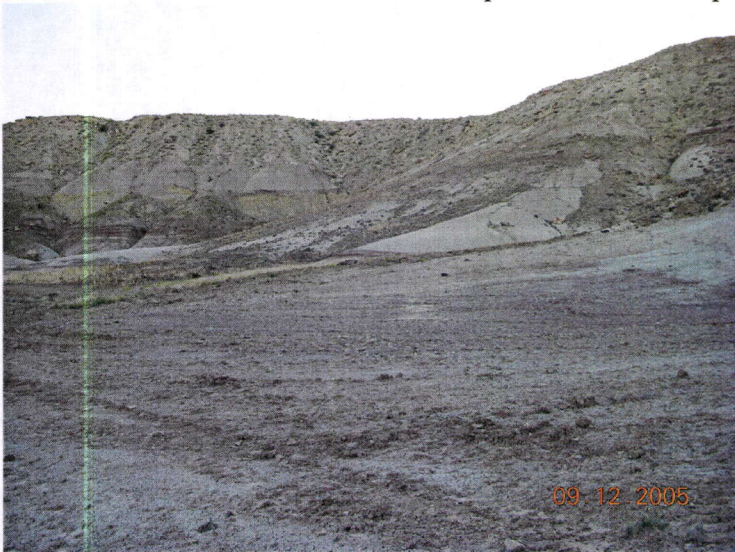
The mine area has been graded to closely match the surrounding area. The grading is good enough that I would accept it as complete, but I was told by another party (not the operator) that additional clay may be taken from this pit for another job.

**Photo 1.** This photo and Photos 2 and 4 show various views of the disturbed area.

If the operator does not plan to do further mining at this site, it should be seeded this fall. The disturbed area, particularly the flatter areas where there was probably some vegetation before any mining, should be roughened, and seed should be applied right after surface preparation. I did not note the species present in the undisturbed area, but from Photo 3, vegetation appears to be dominated by shadscale and galleta.

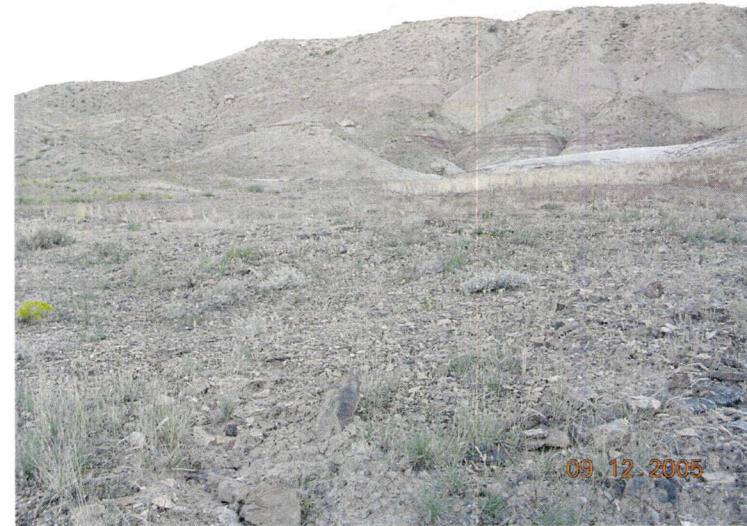
Soils in surrounding areas appear to be derived from shale and sandstone. I could not tell that the operator had salvaged any soil. This was probably not necessary in the shale outcrop areas, but in adjacent areas, there are places with a sandstone veneer over the shale (Photo 3). It is probably very thin and probably would have been difficult to save without contaminating it with the underlying shale.

There is essentially no vegetation on the clay outcrops, but on the flats where there is a sandstone veneer, there is about 15 percent vegetation cover. Photo 3 shows the cover in an undisturbed area.

**Photo 3.** An adjacent undisturbed area. Note the amount of vegetation on the thin veneer of soil in the foreground compared to the clay slopes in the background.

If additional areas are to be disturbed, the operator should try to salvage topsoil. This may be difficult as discussed above.
